MONARK TEST SOFTWARE and Windows 11

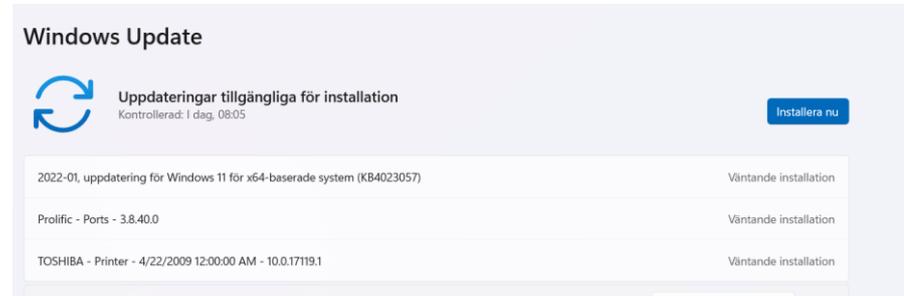
Unfortunately, we have realized that the problem may recur. This is because when you run Windows update, a new driver will be installed automatically. If that driver is installed, the problem will recur.

In the first place, do not install that driver, if it has done so see the info below..

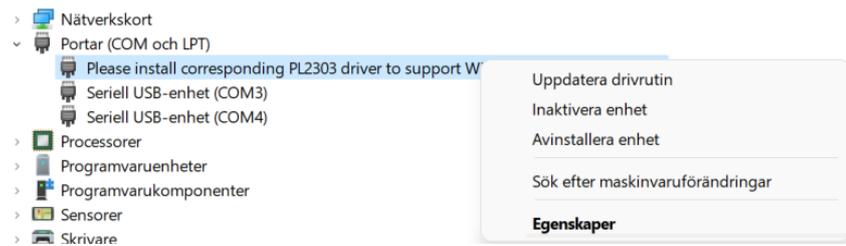
You can see in your device manager which driver version you have installed

If it looks like above, right-click on that driver and uninstall it.
